COUNTIES (MD/PA) WASHINGTON/FRANKLIN
M&D milestone no. 111 (115)
MHT-HSI no. WA-V-212

FIELD SHEET: MASON & DIXON LINE, MARYLAND-PENNSYLVANIA BOUNDARY MARKER SURVEY

MASON & DIXON WEST LINE: MILESTONE NO. III (115)
CLEAR SPRING QUADRANGLE

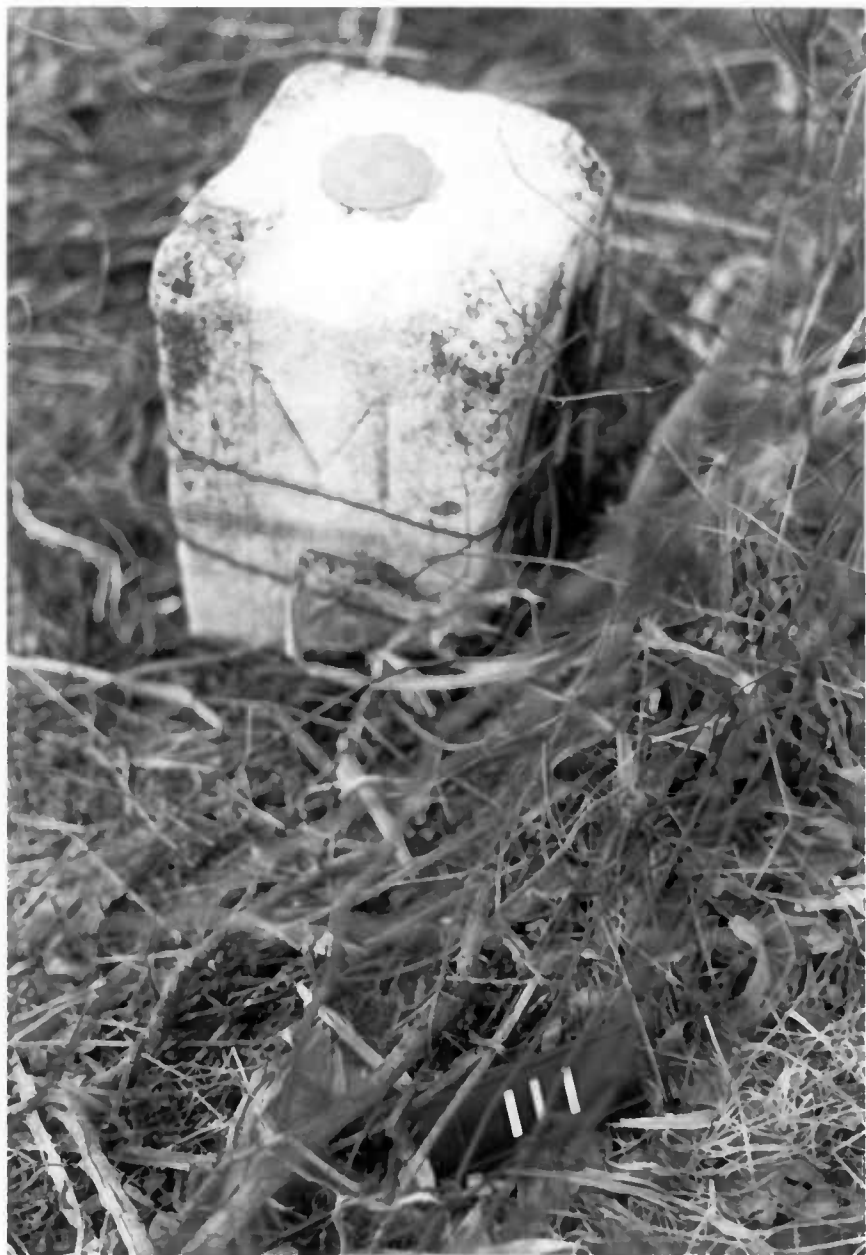
NATION RD ON HIGHWAY MILESTONE III (115)
SE CORNER (111)

1979-81 Inspection notes: order no. 111 (115); photos/negatives/slides no. 111 (115)
111 (115). Original M&D milestone of 1767, relocated a short distance westward
and reset 1902, in place, in good condition, on firm foundation. Letters
clear but all surfaces quite weatherworn; most of top smeared with mortar; (over)

USC&GS triangulation station DITTO (1935) disk set in apex. Two/^{nonfunctional}wires around middle circumference noted in 1967 still in place.* Protected by site.

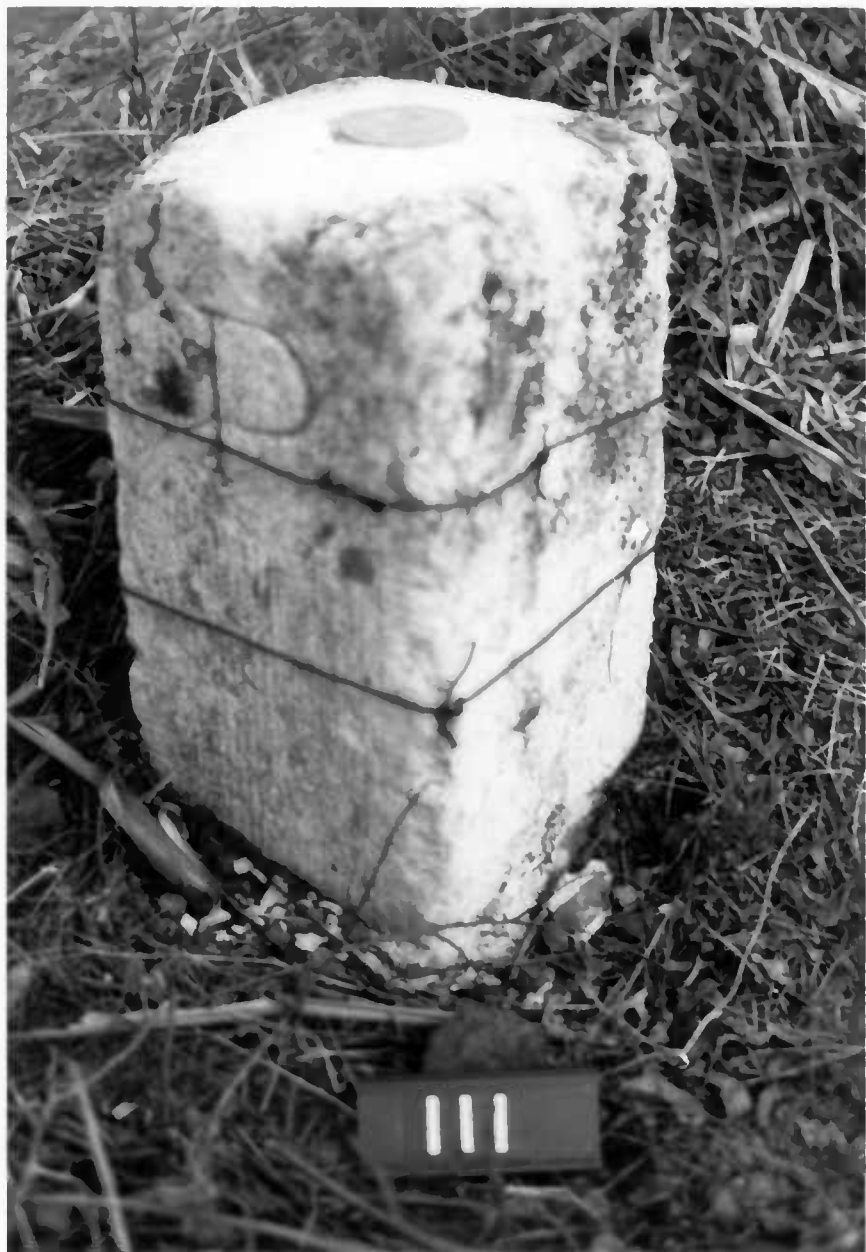
MASON-DIXON WEST LINE: MILESTONE III (115)
NW CORNER (P1-)

The Dittos were very hospitable, and took us to the board fence to point us in the right direction. We neglected to ask what the two wires meant, but assume they indicated the true property boundary lines (corner), rather than where the N-S fence is, a few inches to the east. Gerald Sword had noted the wires in his letter to Ronald Shank (DNR Indian Springs Wildlife Management Area) 9/20/67. The stone is not cracked in any way, nor was it repaired so as to require binding of this sort.

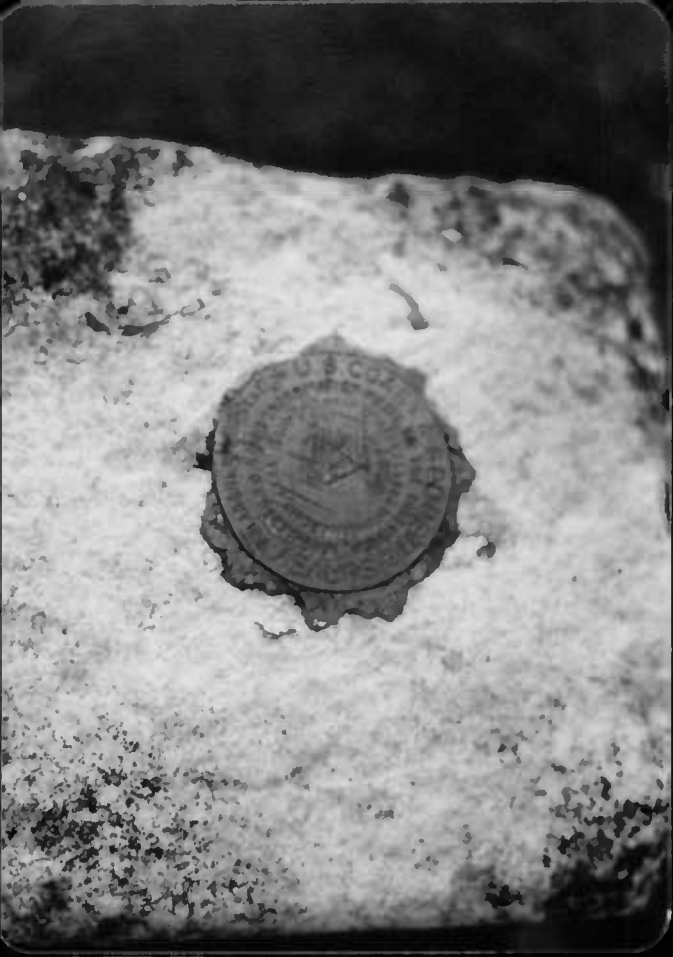
M&D WEST LINE: MILESTONE 111 (115)
CLOSEUP OF "DITTO" TRIANGULATION
STATION DISK

0.7 mile to William O. Ditto house on W/S (new red brick 1-story; old white frame)
DESCRIPTION/MEASUREMENTS: original/~~replica/replacement~~/date 1767; squared oolitic
limestone post; standing about 1 1/2' above ground; P on N/S, M on S/S; USC&GS disk
N face (PA): 12 1/4" wide x 21" high; P clear & intact; circle panel, fluting & margins
remain; small chips all edges & corners; big chip top NE corner
E face: 12 1/4" wide x 18" high; most fluting & margins remain, but weatherworn
S face (MD): 12" wide x 17 1/2" high; M clear & intact; most of circle panel, fluting
& margins remain, but weatherworn; small chips all edges & corners
W face: 12 1/4" wide x 22" high; fluting & margins remain but very weatherworn,
top: planes barely discernible, weatherworn, no fluting remains; USC&GS
bench mark: USC&GS triangulation station DITTO (1935), disk
